Site Visit to Standard Chlorine 05/07/02 - photos taken with digital camera by John Malleck, EPA Region 2

**Standard Chlorine Site Visit 05/07/02 - Photos taken by
Kristin Dobinson, EPA Region 2**

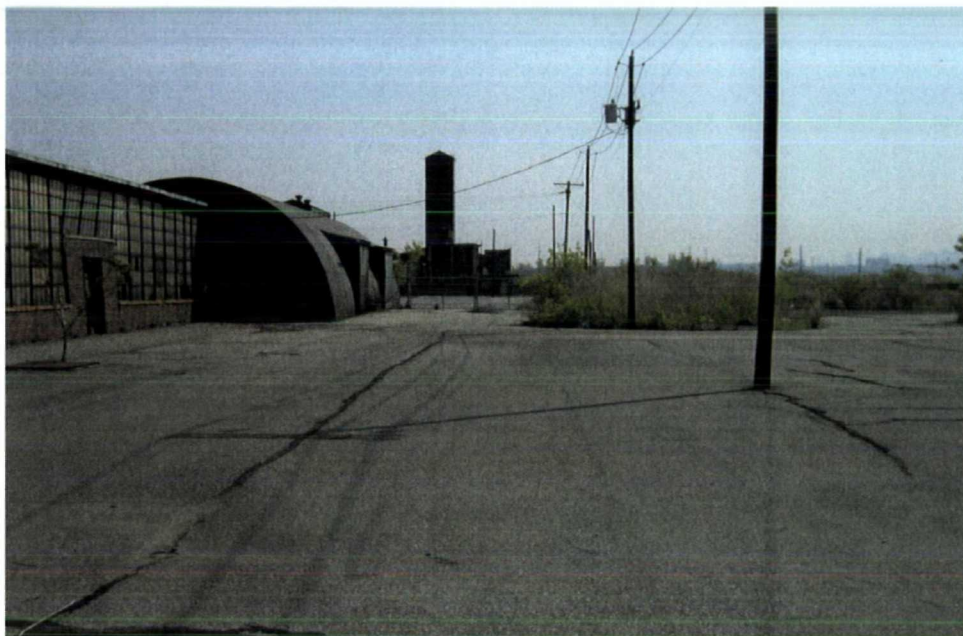
Looking east at naphthalene processing area

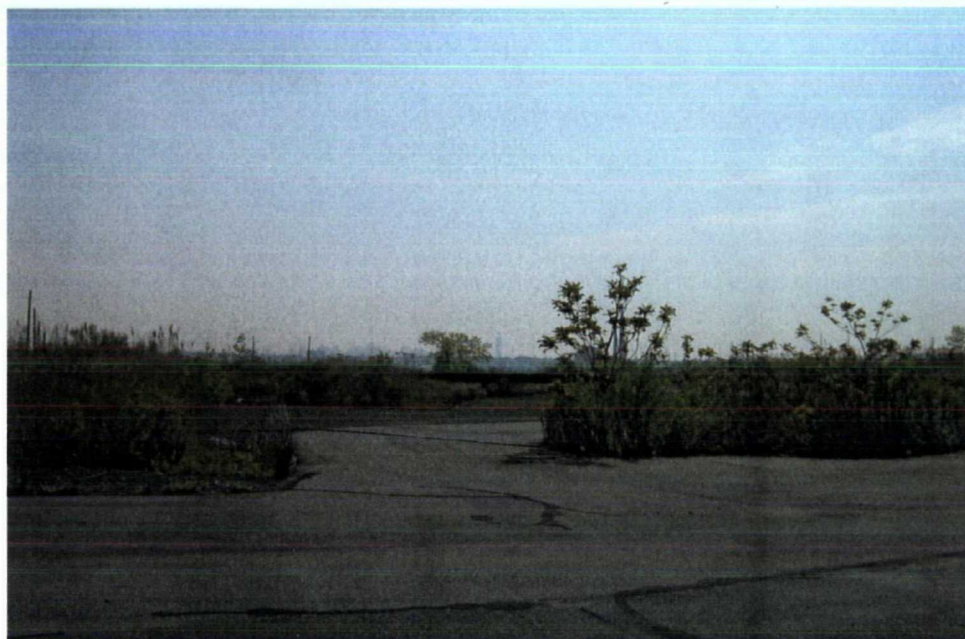
Looking east towards lagoon area in distance

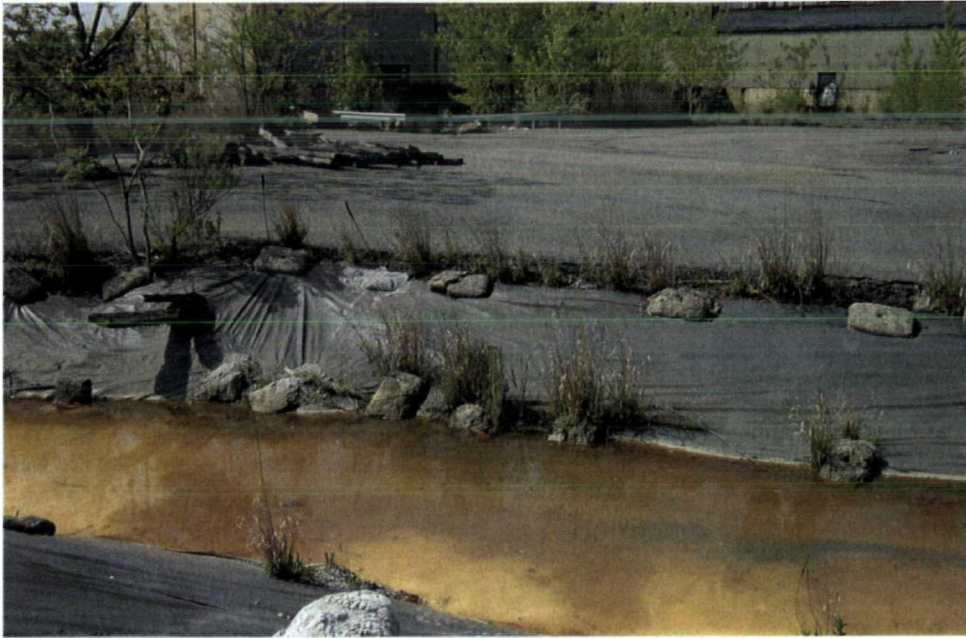
Southern Drainage ditch - note the wood coming through the liner.

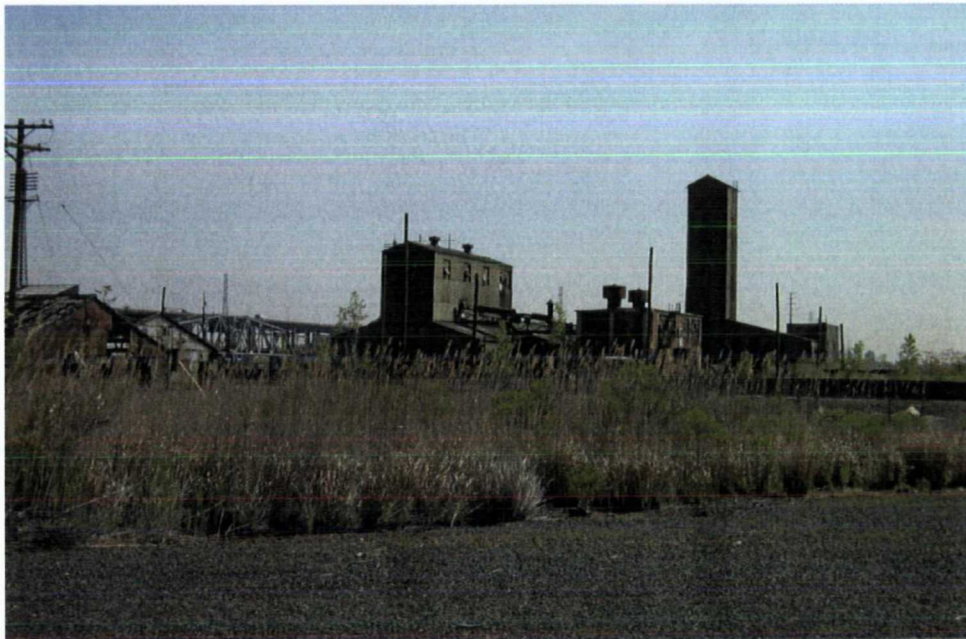
Looking east towards naphthalene processing area.

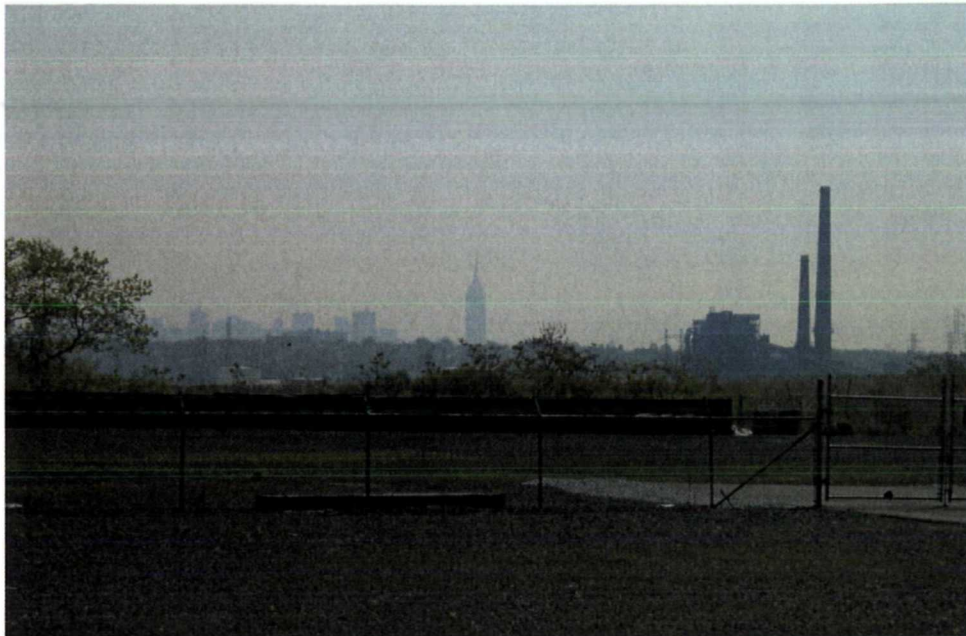
Looking east towards lagoon area (on far side of second fence).

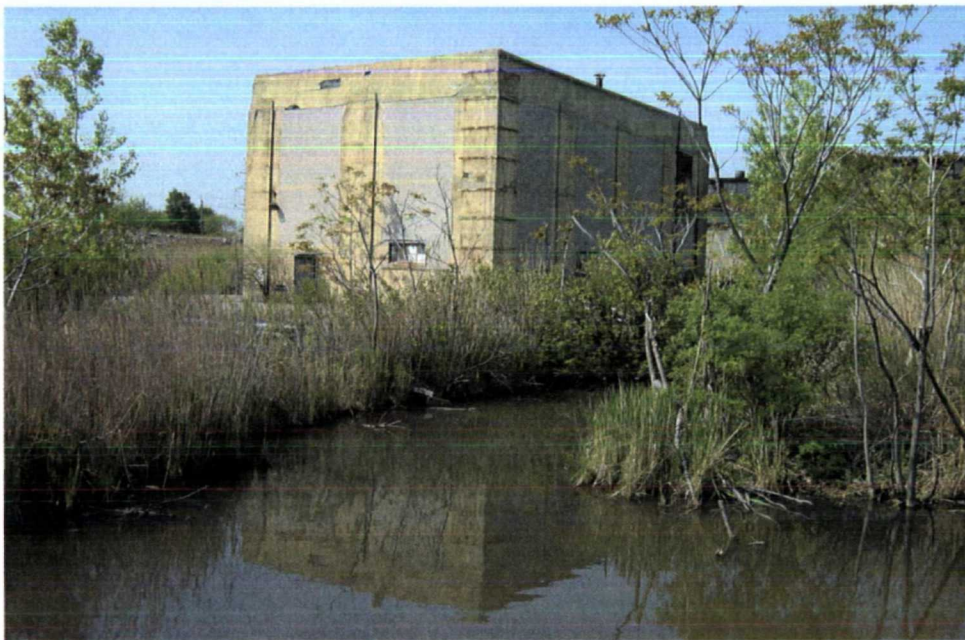
Cove off of southern drainage ditch located in between Buildings 3 and 4.

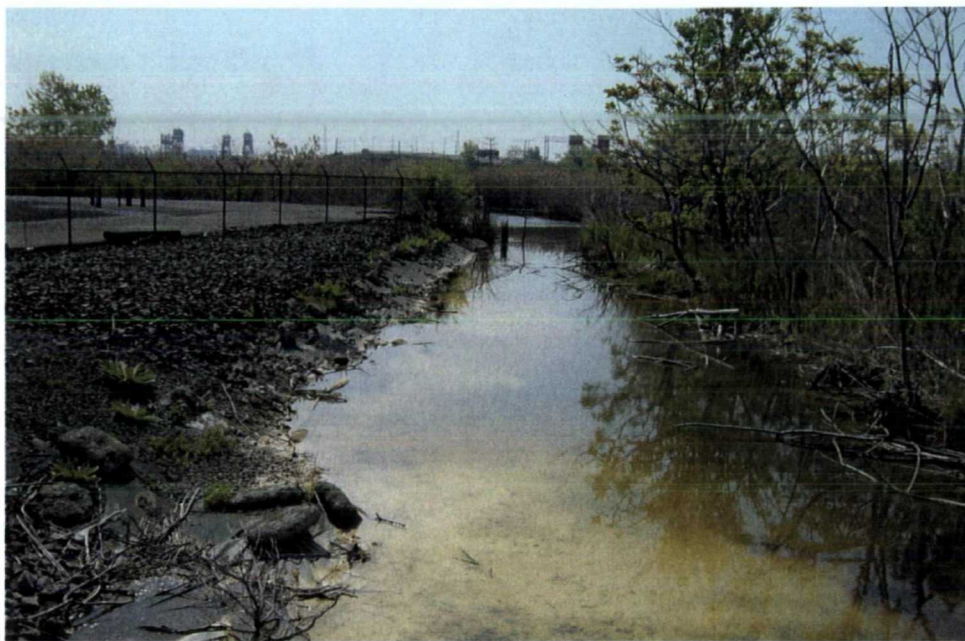
Southern drainage ditch looking from center of site towards the confluence of the upgradient portion with the western end of drainage ditch.

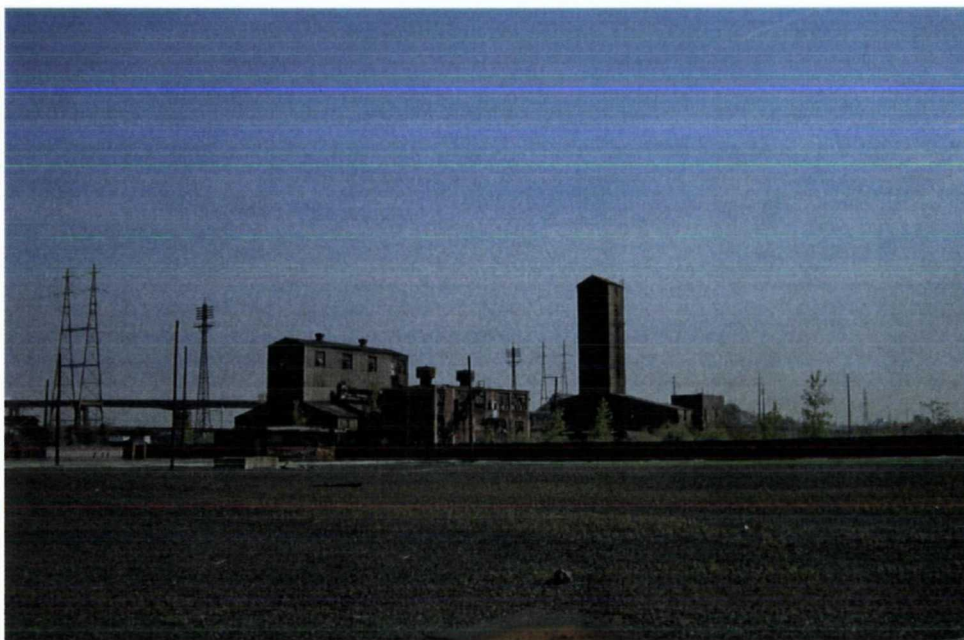
Looking northeast across gravel IRM for chromium exposure.

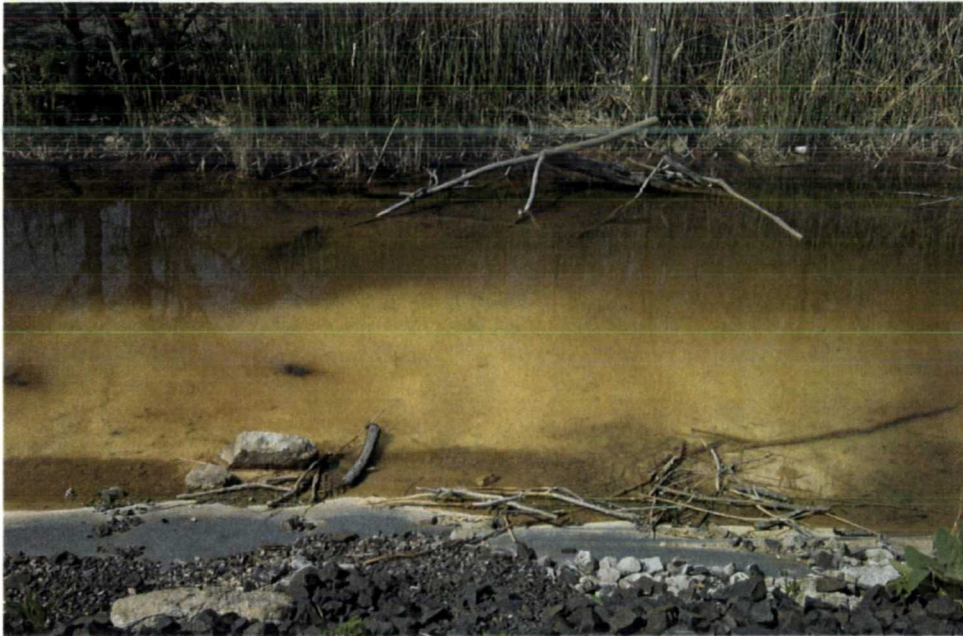
Southern drainage ditch. Note brown seeps in white deposit.

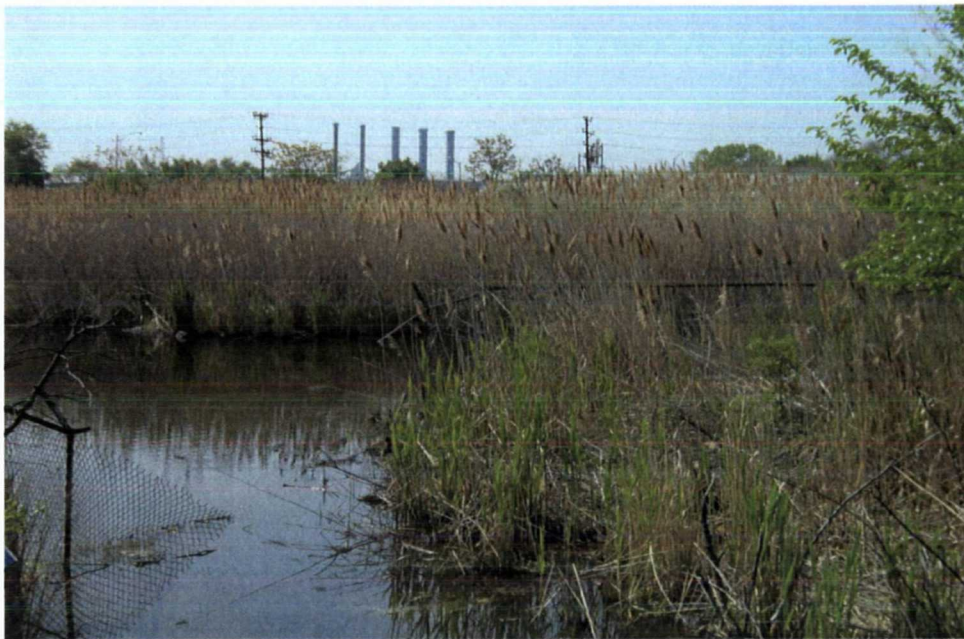
Southern drainage ditch where the upgradient portion conflues with western portion and opens up into wetlands open water.

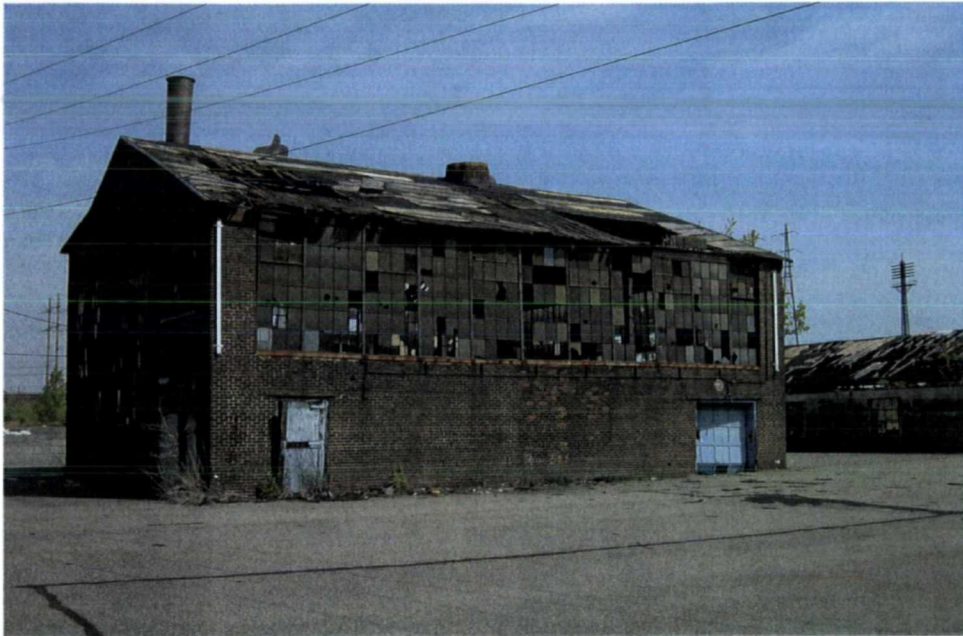
A building in old naphthalene processing area.

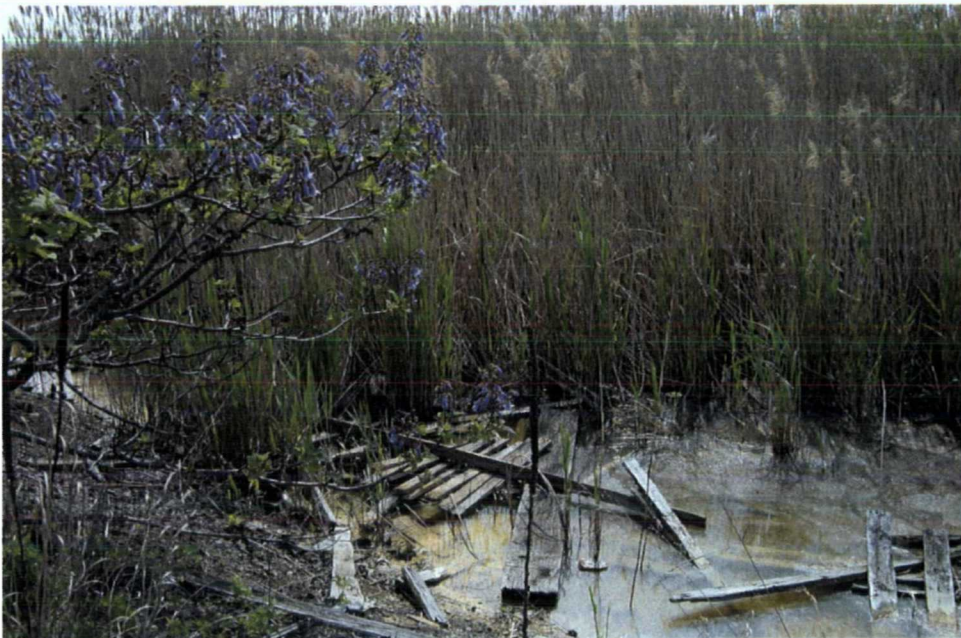
Debris in southern drainage ditch.

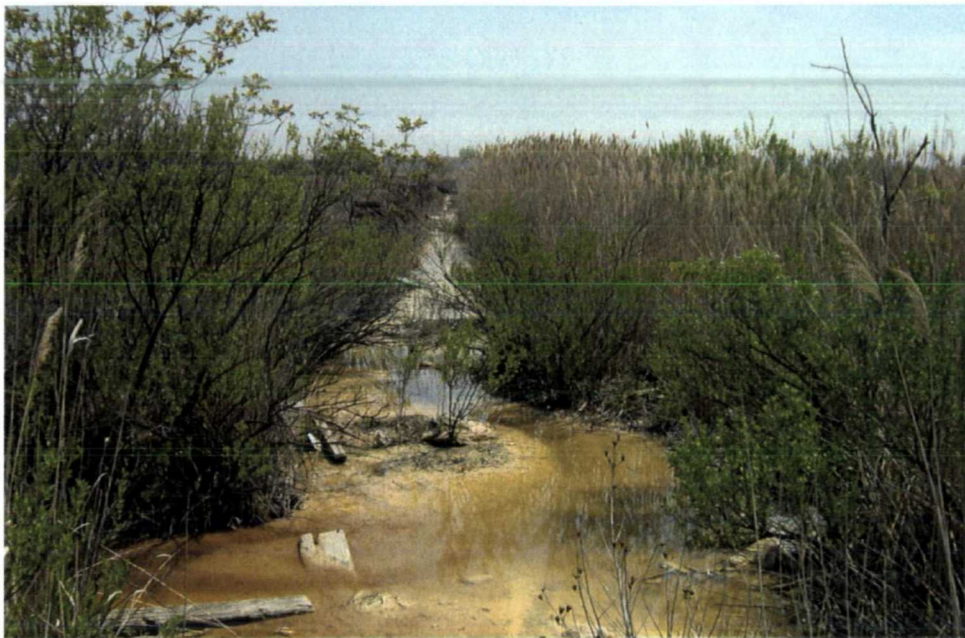
Southern drainage ditch looking east towards Hackensack River.

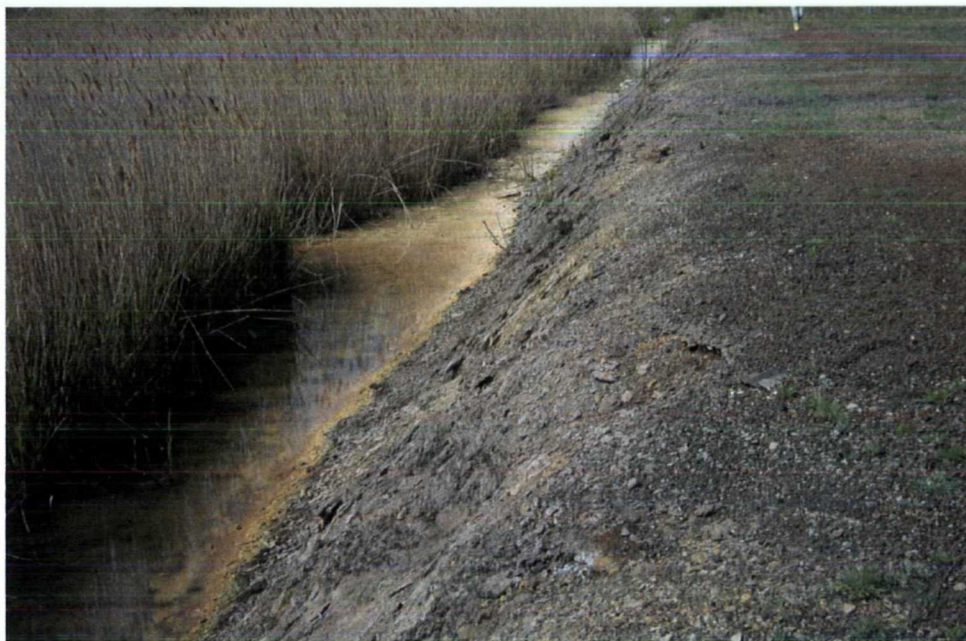
Eastern end of southern drainage ditch looking west.

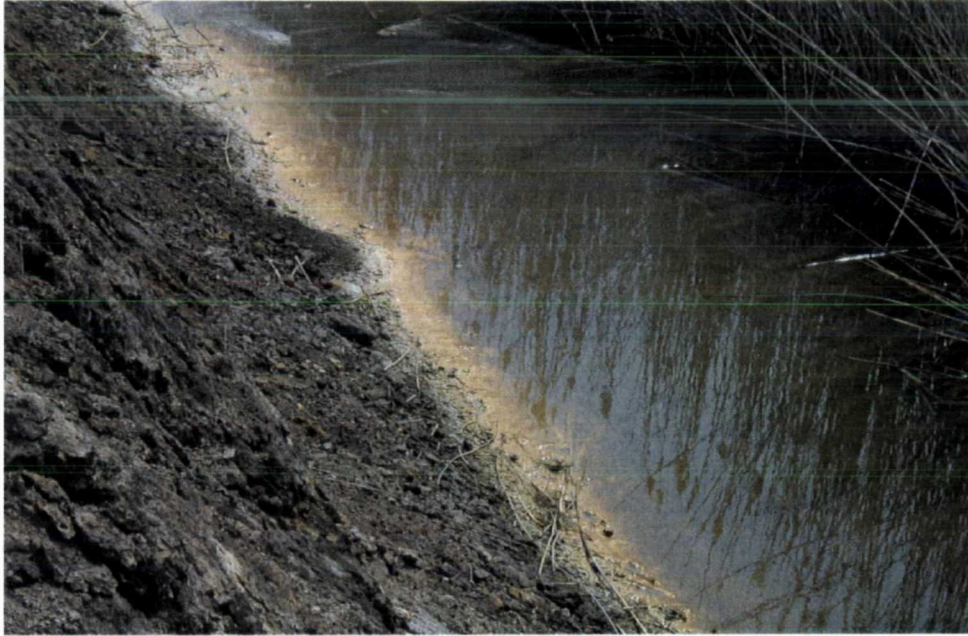
Southern drainage ditch.

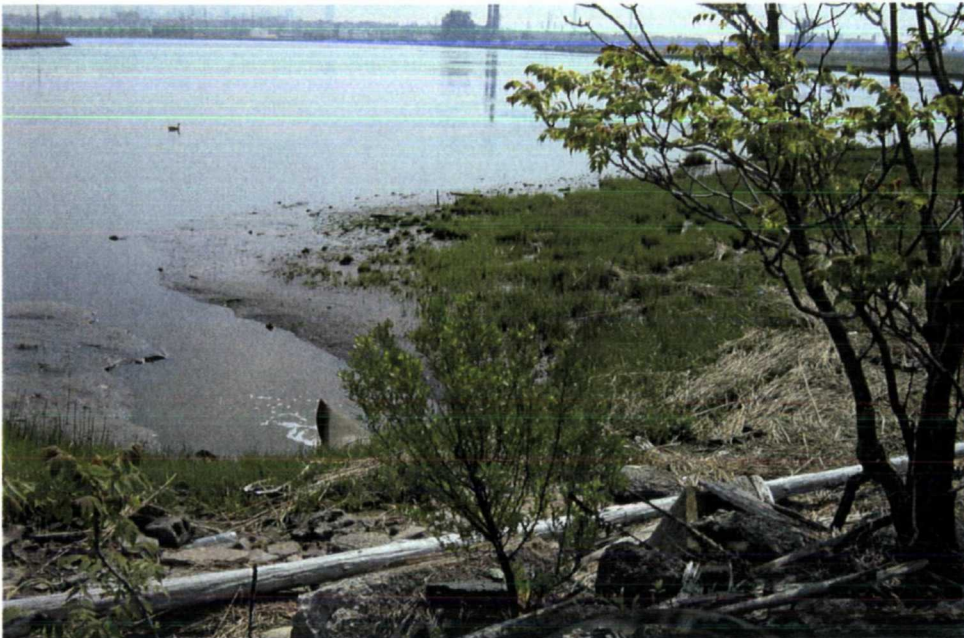
South outfall into Hackensack River.

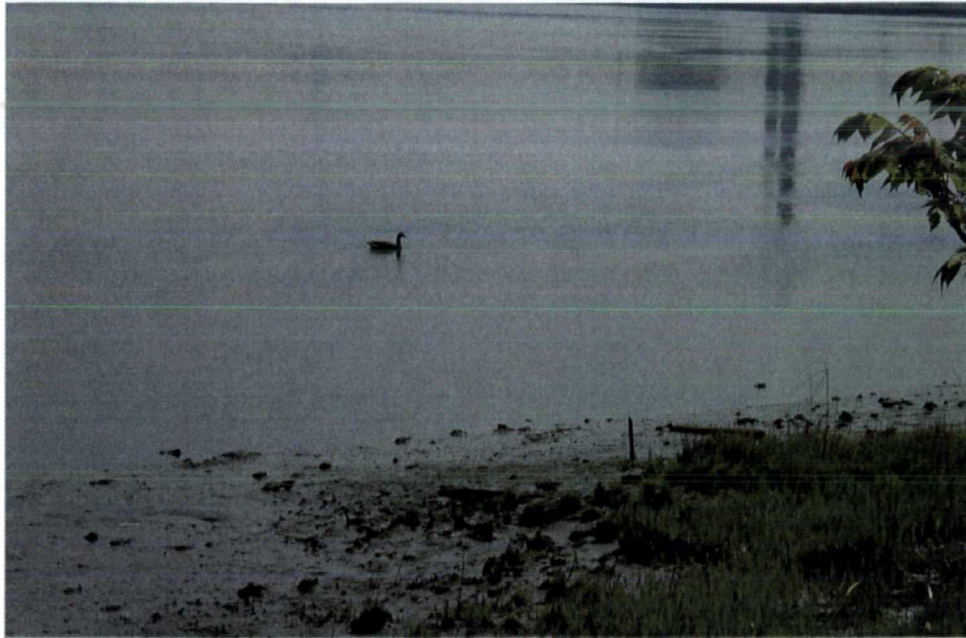
Duck in Hackensack River just downstream of south outfall.

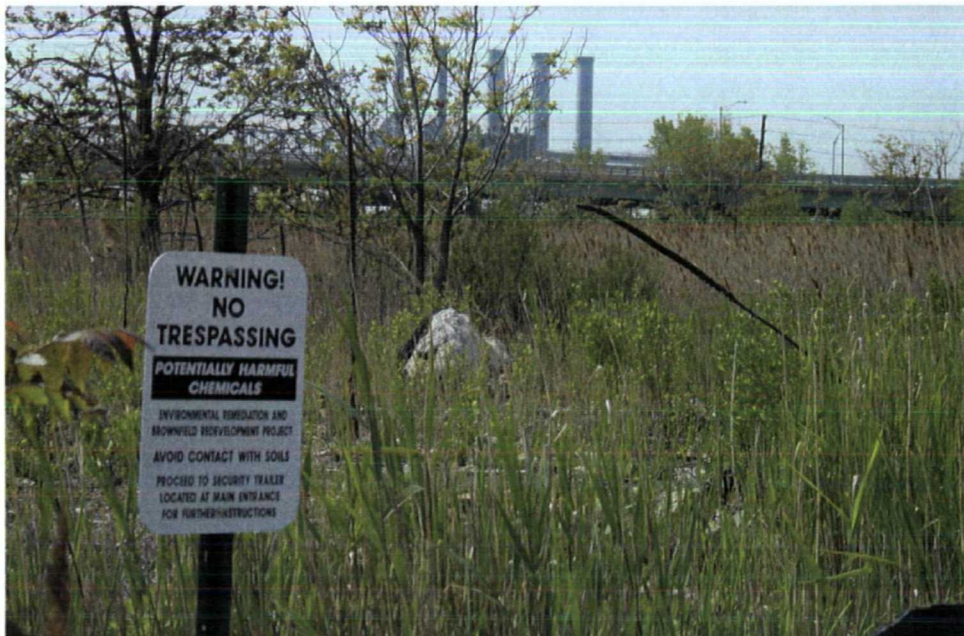
Warning sign on property at bank of Hackensack River.

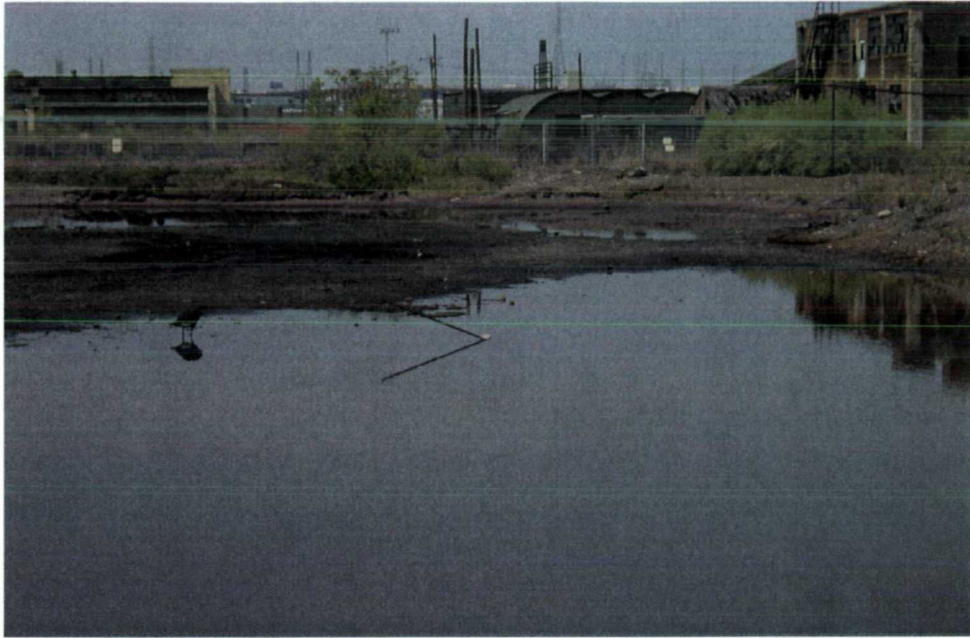
Canada Goose in lagoon.

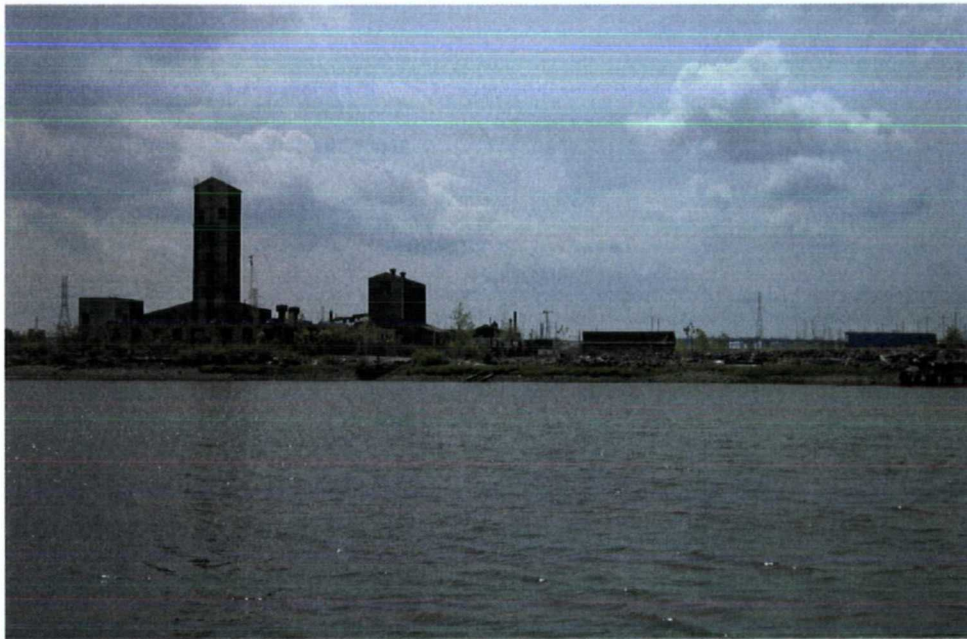
Standard Chlorine from Hackensack River.

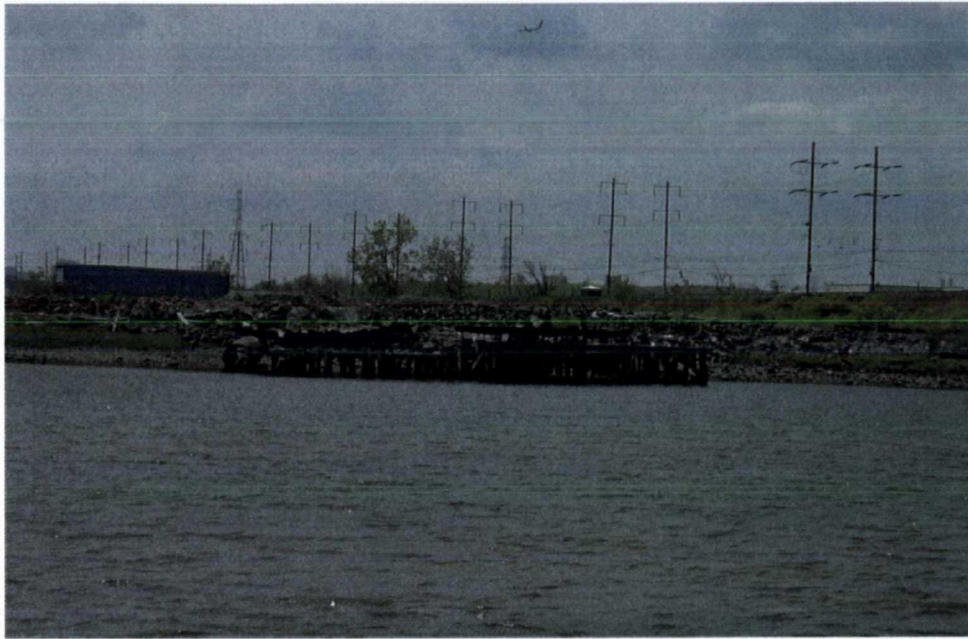
Pier upstream of Standard Chlorine. Off Diamond Shamrock property.

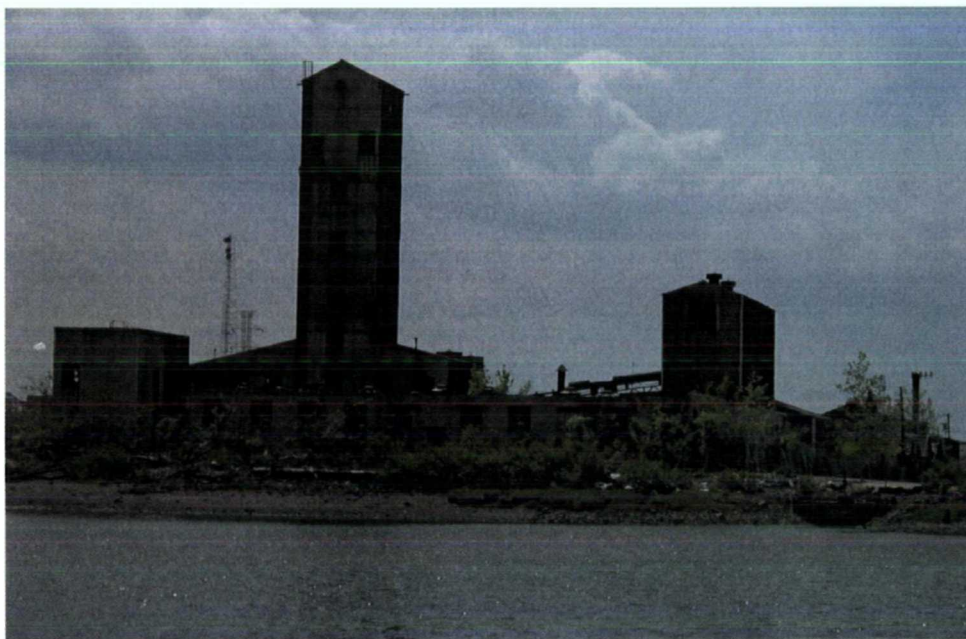
Standard Chlorine from Hackensack River.

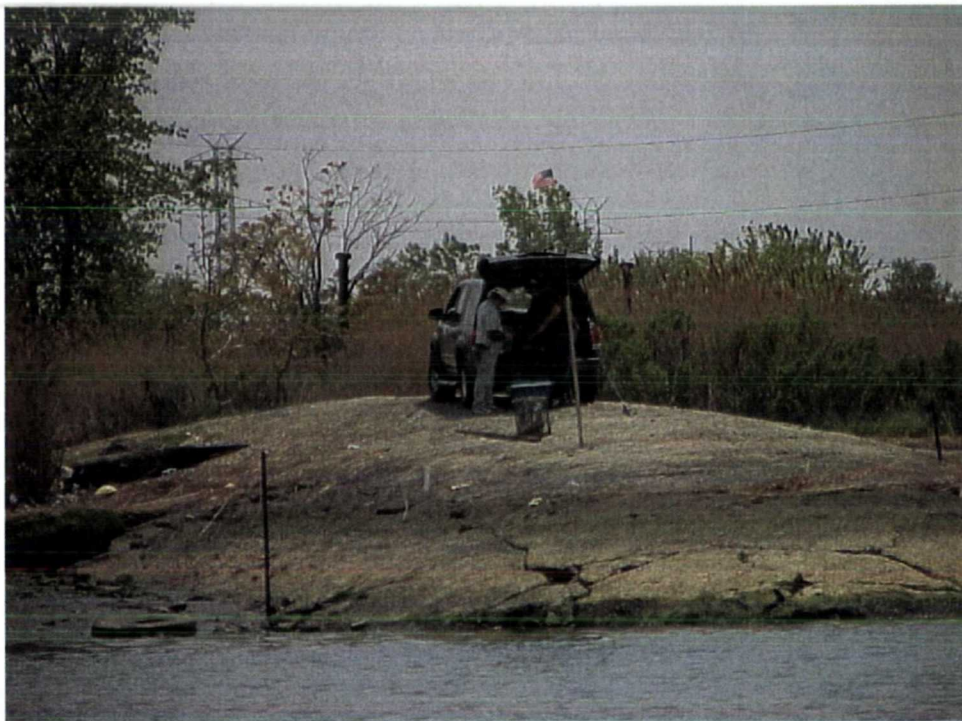
Fishermen just upstream of Standard Chlorine site.

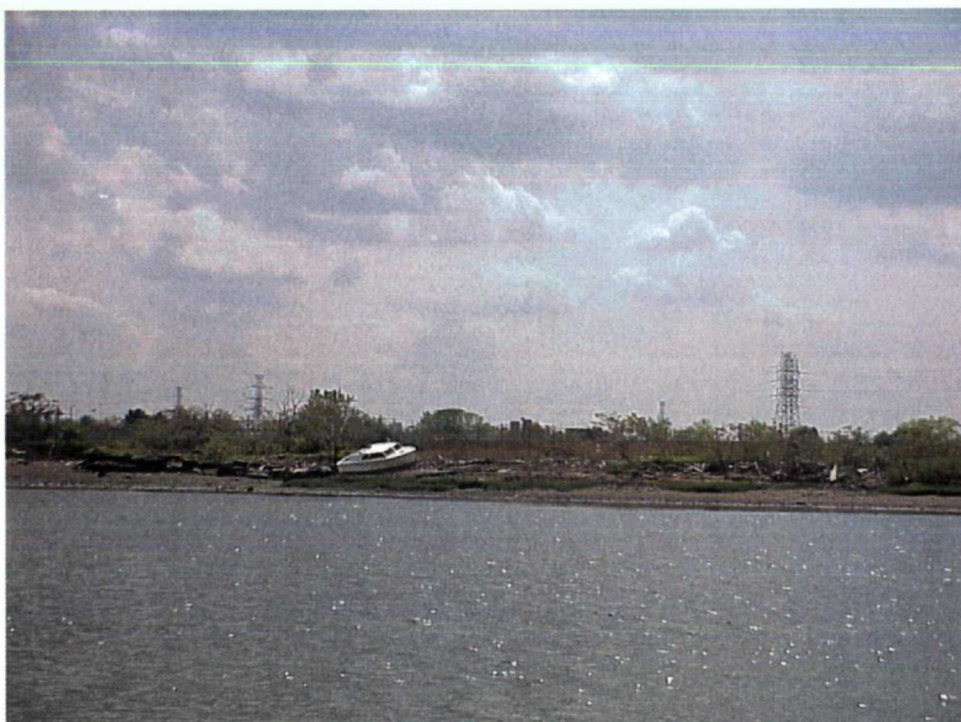
Boat washed up on the banks of the Hackensack River, bordering the Standard Chlorine property.

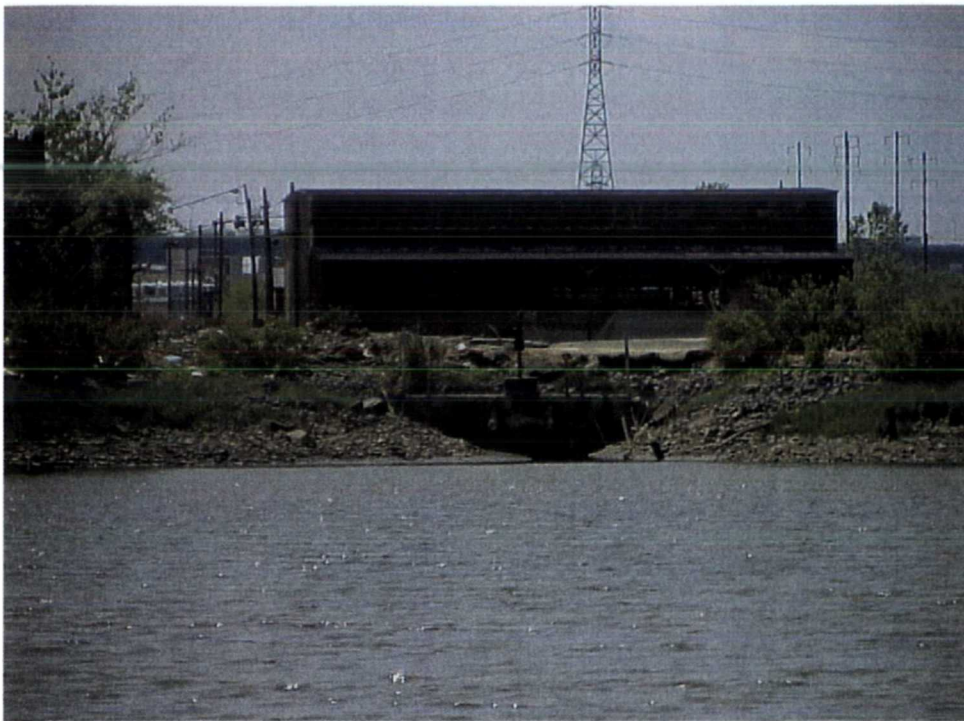
Northern outfall

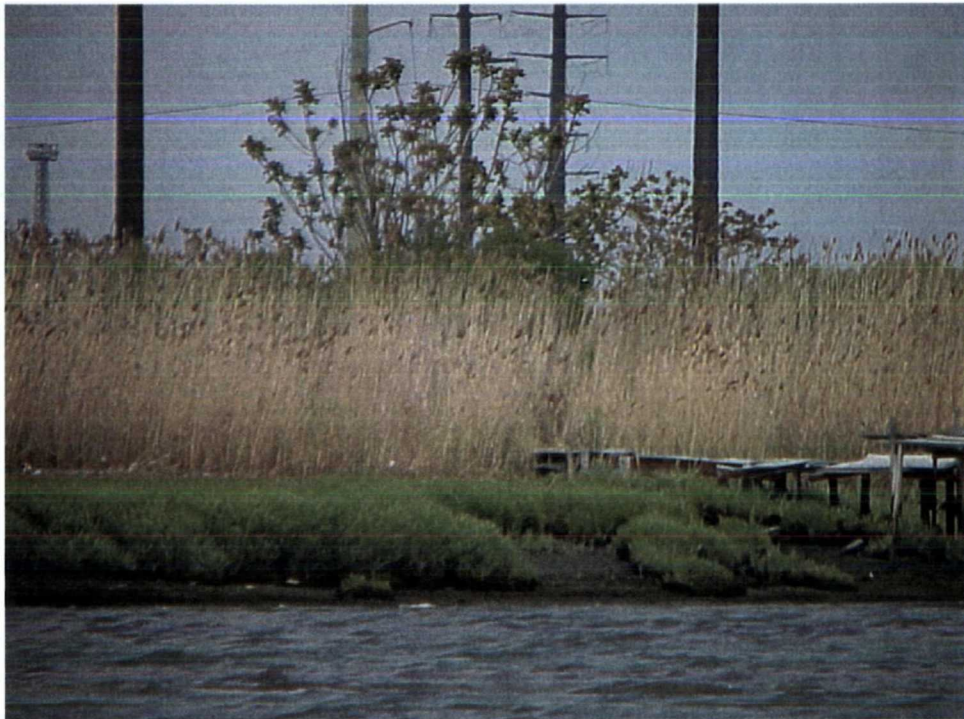
Makeshift dock at popular downstream fishing spot.
